## Study of Human Intervention on River and its Impact on Local Economy: A Case Study of Chamta Channel of Darjiling District

**Abstract :** *The geometry of channel bed and bank boundary as well as long profile is nothing but the combined effect of the channel hydro-geomorphological drivers in any riverine environment. But the human intervention is considered as one of the important independent variables of river hydraulics. The present paper deals with the study of human interference along the Chamta channel in the piedmont of Darjiling district of West Bengal. The present research incorporates the linkage between the change in hydro-morphology and its impact on local economy. The local economy can be considered as a construct which can be reflected through many indicators like the change in land use land cover, change in water fish availability in channel, change in occupation structure, change in population size of the buffer villages along the Chamta channel the change in riverine environment puts its direct and indirect impact on local economy on the basis of available natural resources along the Chamta channel.*

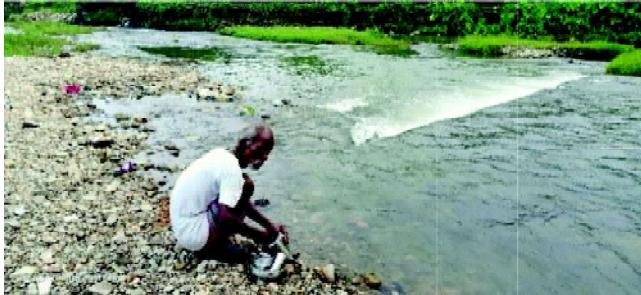
**Photo 15:** Washing utensils by using Chamta water at Gourcharan area

The released domestic waste water, solid waste, untreated residue of human and animal's excreta directly make the water quality of Chamta poor. This toxic water has been found to increase incidence of skin diseases among the local people. This is further to mention that the domestic septic tanks are open to the channel of the Chamta. As a result, the river water is neither used as drinking water nor for washing, bathing and cleaning linens. Water samples are tested at field by using field kits and water quality index has been prepared to observe the change in water quality of Chamta channel at some selected stations throughout the year. Poorest water quality has been observed in pre-monsoon months. Though it improves a little in the monsoon months. Best water quality has been recorded in late-monsoon season. It again deteriorates gradually from December to May. The water sample also been tested

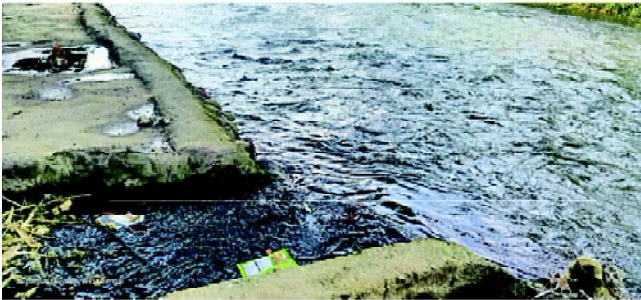
**Photo 16:** Domestic drain outlets are discharging at Chamta

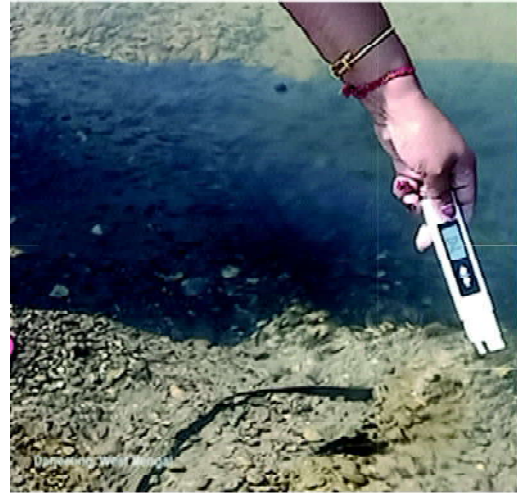
**Photo 19:** Using field kit to measure the chemical parameters of the water sample collected from Chamta channel

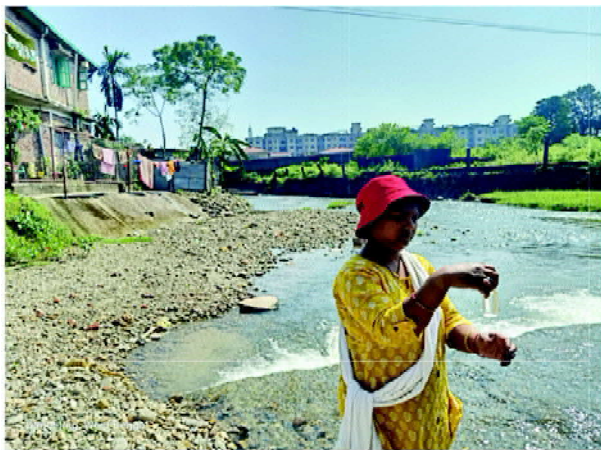
**Photo 20:** Water sample collection from Chamta channel at Gourcharan area for water quality measurement
